State of Utah DEPARTMENT OF NATURAL RESOURCES Division of Oil, Gas & Mining

Inspection Report

Mine Name: Tony M	Permit number: M0170001
Operator Name: Plateau Resources	Inspection Date: May 31, 2007
그렇게 마다구나를 가지 않는 그 사람이 없는 것이다.	Time: 9:00 to about 11:30 AM

Inspection Dated: May 31, 2007; Report Dated: June 19, 2007 Photographs M0170001, Tony M Mine, Plateau resources

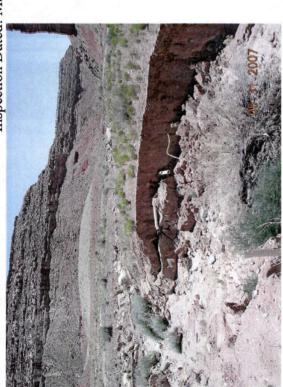
In October 2006, the area received a substantial amount of rain, and the resulting runoff plugged and washed out culverts and washed out some areas where a drain field was buried. Various views of the area are in

Photo 1.. Erosion in the stream channel adjacent to the leach field.

Debris from the drain field and camp needs to be cleaned up. This is in an area currently proposed by Denison Mines for a new leach field as well as a maintenance shop, warehouse, mine office, dry, and topsoil storage areas. Plateau may be able to have Denison clean up this area during construction.

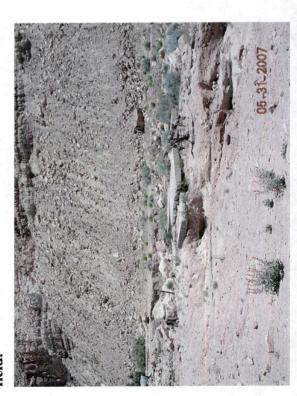
Photos 1 through 4. In these photos, one can see PVC pipe that was part of the drain field as well as concrete and wiring that may have been part of a camp that was at this site until about 1980.

Photo 2. Concrete that was exposed during the floods in October 2006.

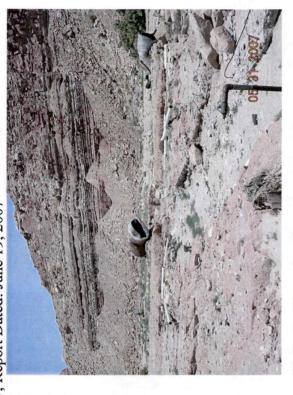
Photo 3. The culverts were washed from an upstream crossing. Note the PVC pipe.

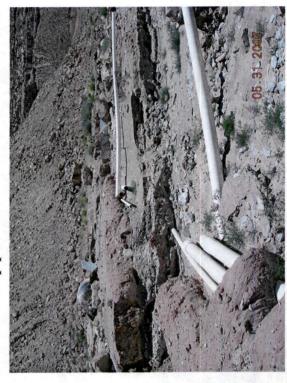
Photo 4. PVC pipe from the leach field.
